Research Report 1524

MANPRINT Evaluation: AN/TRC-170 Digital Troposcatter Radio System

Gregory S. Krohn and Samuel E. Bowser
Essex Corporation

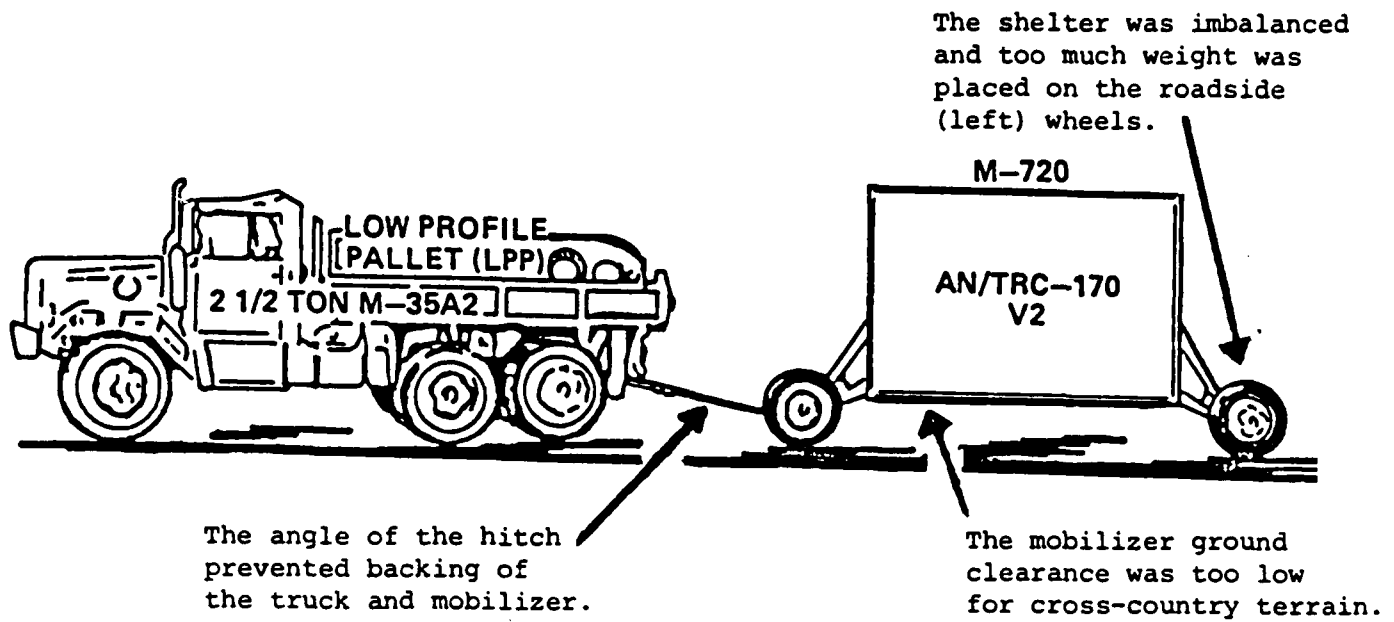
Figure 8. The M-720 mobilizer carrying the S-665 shelter. (The actual configuration of the mobilizer differed slightly from the graphic representation.)

- c. The mobilizer cannot be driven in reverse when towed due to the angle of the trailer tongue when hitched. The trailer tongue was raised approximately 2.5 ft at a 35-deg angle when it was attached to the hitch of the 2.5-ton truck. Backing the mobilizer would result in equipment damage to the hitch or tongue as forces would cause the tongue to fold over.

Implications: The mobilizer may not be suited for cross-country use where rough terrain will be traversed and backing in reverse is a frequent maneuver. Equipment such as the trailer tongue and wheel lugs may be damaged. Crewmen may be injured as they attempt to manually position the mobilizer.

Data: There were six mobilizers (M-720) used for the test; four were dead-lined due to sheared off wheel lug posts on the roadside wheels. Five of the six mobilizers have some damage related to cross-country travel and the weight of the trailer. Crewmen were interviewed and 94% stated that the mobilizer could not be moved manually by the present crews without additional help. The data collectors (97%) and test directorate personnel (92%) agreed. The supervisory personnel stated that a minimum of 5 persons were required to do this task.

Potential Solutions: The internal shelter configuration had all the electronic components positioned on the roadside of the mobilizer. Perhaps the electronic components could be repositioned on both sides of the mobilizer in order to balance the load. However, the only way to avoid exceeding the weight capacity of the mobilizer may be to use a larger-capacity mobilizer.

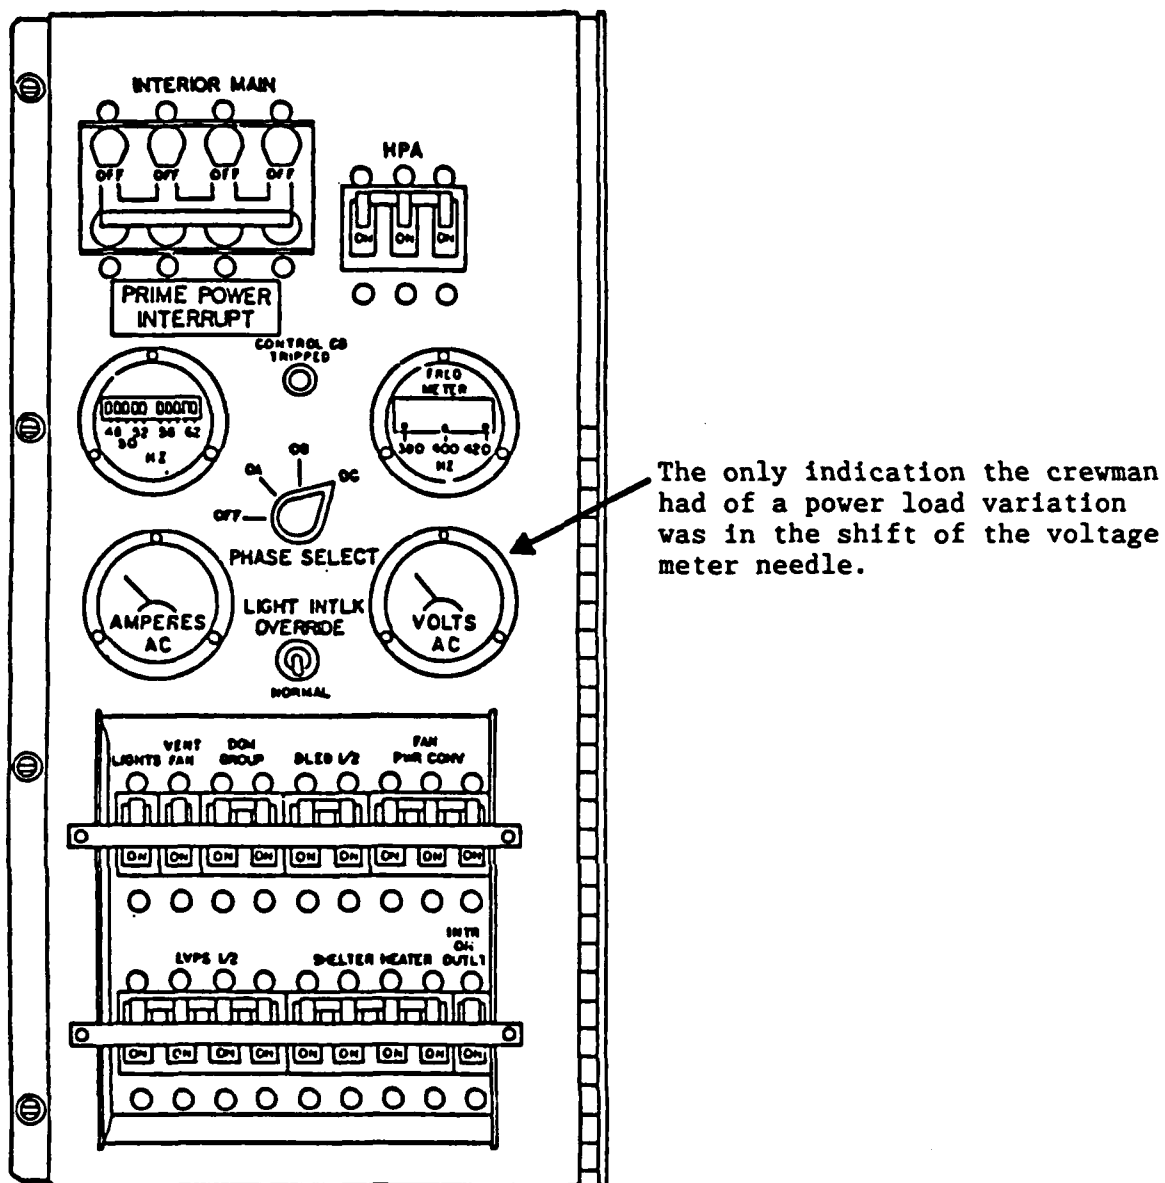
Figure 9. The main power panel in the V3 shelter.

- a. The generators cannot be switched from one to the other without shutting down the V3 system. The generators need to be switched when fuel is emptied or repairs are required. Once the V3 is shut down, a period of 10 to 15 minutes is required for system warm-up before radio transmissions can be resumed.
- b. Figure 9 shows the V3 main power panel. The generators do not have a built-in capability to adjust for power load variations. When power load variations occur, the operator must see the variation on the power panel voltage meter in the V3 shelter or on the generator and then adjust the generator. Power load variations occur when components in the V3 shelter are turned on or off.

Implications: Interruptions to the radio transmissions for generator switch-over occurred every 6 hrs. Unexpected shutdown for generator failures resulted in lost transmissions. Failure to adjust the generators for power load variations may result in a generator shutdown.

Data: The interruptions to the radio transmissions resulting from the generator shutdowns occurred throughout the test.

Potential Solutions: Provide the generators with switching capability that provides continuous power without power fluctuations. The generators should be able to automatically adjust for load variations.

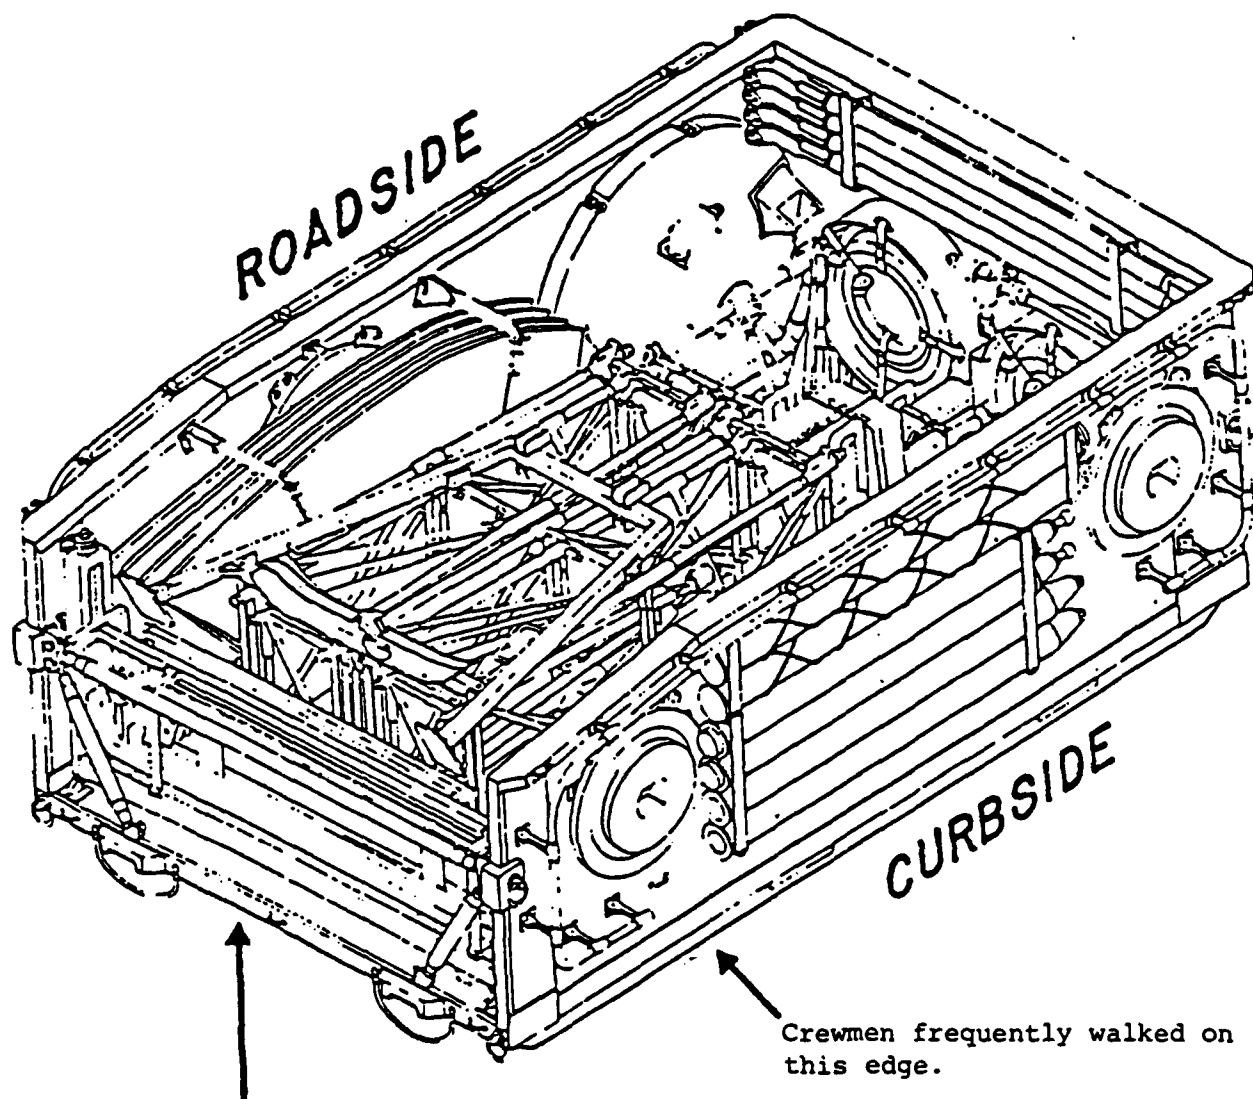
Description of the Problem: Figure 10 shows the low-profile pallet and its contents. The loading and unloading of the low-profile pallet for the V2 system (9.5 ft) antenna is unsafe to perform by three crewmen (AN/TRC-170 V2 crew size). The weights that must be lifted and carried exceed MIL-STD-1472C maximums for three soldiers. The unit (Heavy Tropo Company) does not have other personnel available (TO&E) to support the crews in the field to assist in lifting material. The system can not be set up with a two-man crew making the system un-emplaceable if any crew member is injured or otherwise unavailable. The units may set up in isolated locations and other personnel may not be readily available.

Implications: The crews may suffer injuries such as back strain, muscle strain, contusions, abrasions, or broken bones. The AN/TRC-170(V2) may not be able to complete its mission.

Data: Seventy percent (70%) of the operators reported that it was difficult for three crewmen to lift equipment when loading and unloading the low-profile pallet.

The pallet was approximately five feet above the ground when mounted on the truck bed.

Crewmen frequently walked on this edge.

Potential Solutions: The crew size could be increased by the addition of a maintainer (29M or 29S) to add to the number of persons available for loading or unloading. The procedures for the truss assembly might be modified to reduce the weight lifted by crewmen when disassembling the truss on the pallet.

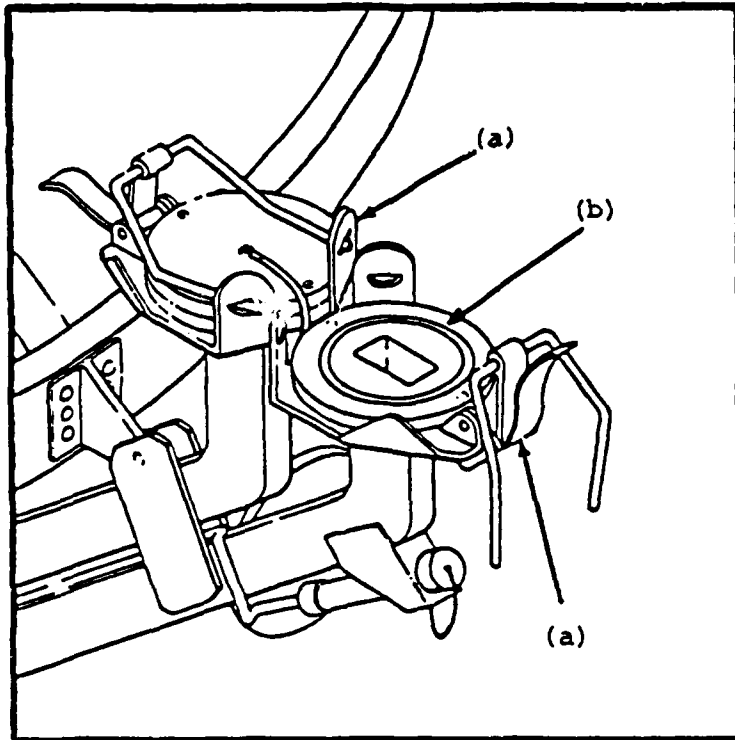
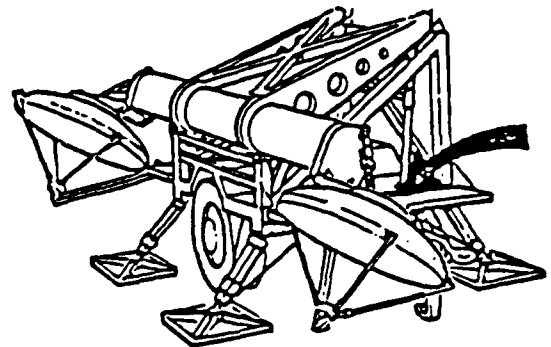
Figure 11. The waveguide latches (a) that were difficult to close and the O-ring (b) that fell out.

Description of the Problem: The waveguides, linking the shelters to the antennas, were frequently damaged including:

- a. The male plug alignment and signal pins bend, loosen, and fall out.
- b. The male plug O-ring forming the moisture seal falls out making alignment difficult and risking loss of the O-ring. Figure 11 shows the location of the O-ring and latch device.
- c. The latch securing the male plug to the female socket was difficult to manipulate and had to be forcibly closed. The latch could not be closed by crewmen wearing MOPP NBC gloves.
- d. The protective transport containers for the waveguides used on the V2 system were attached to the pallet. The waveguides had to be carried by crewmen from the pallet to the antenna. The exposed waveguides were often stepped on or collided with objects. Figure 12 shows the protective container, while Figure 13 shows the position of the waveguides when laid out on the ground.

Implications: Several factors contributed to damaging of the waveguides. Damaged waveguides will prevent transmission. Additional replacement waveguides will have to be supplied.

Data: Two-thirds (12) of the waveguides were damaged and unusable at mid-test.

Potential Solutions: The waveguides should be durable enough for the field environment in which they will be used. Operator training should address the sources and prevention of waveguide damage, especially if the design of the waveguides remains unchanged. Two soldiers, rather than one, should be used to support the waveguide when attaching or detaching it to the antenna in order to keep it evenly supported.

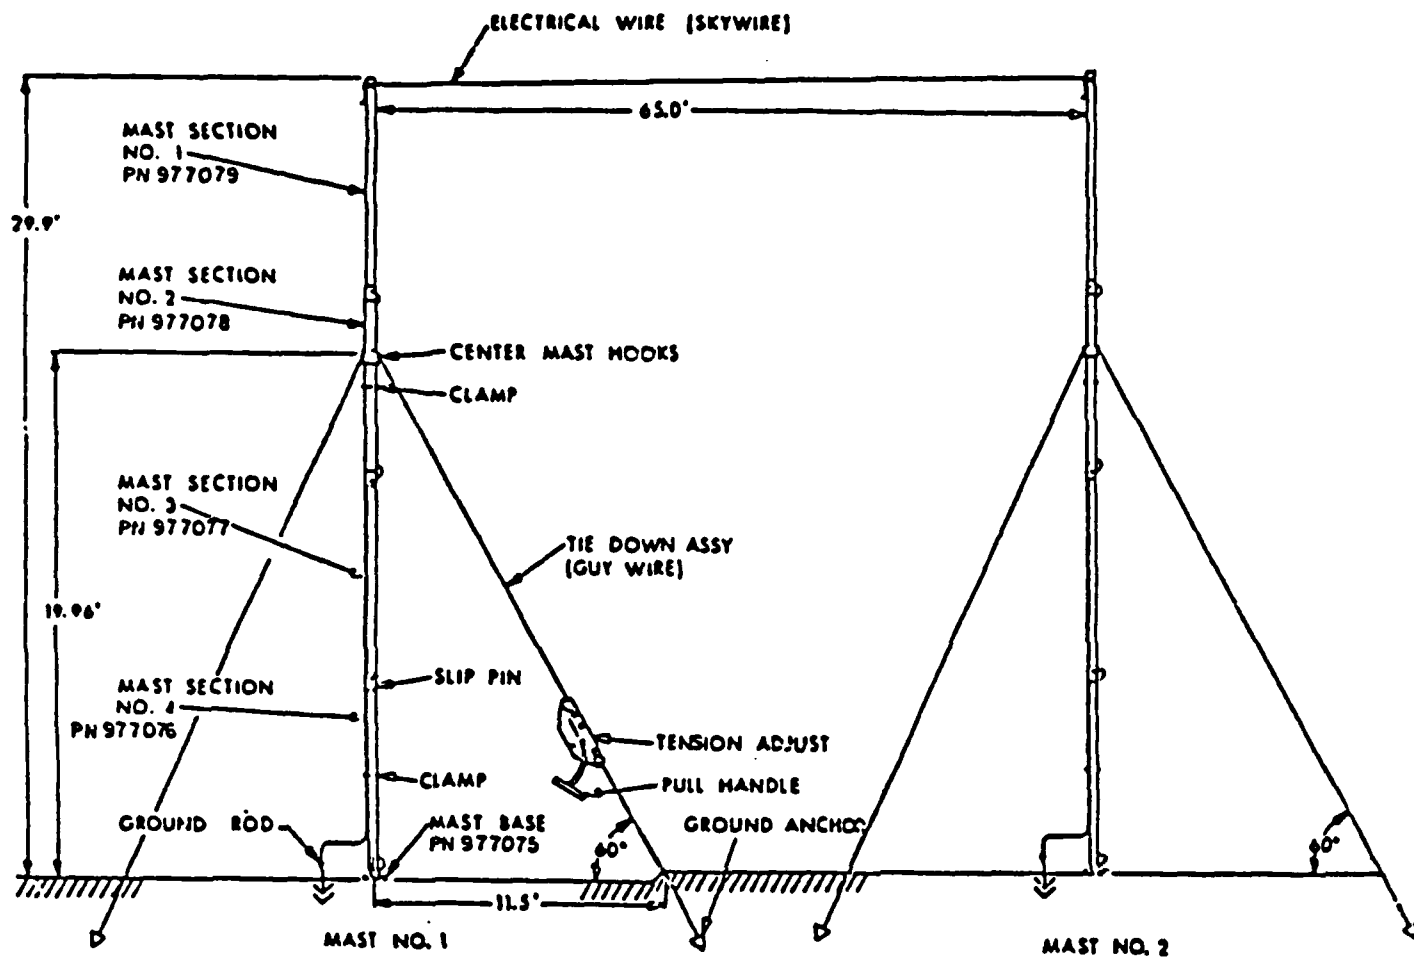
Figure 14. The lightning protection assembly (LPA) that was erected across the top of the antenna structures.

Implications: The LPA is erected next to the AN/TRC-170 antennas and shelter. The collapse of the mast might damage the antennas or shelter. The personnel are also endangered by a collapsing LPA mast.

Data: All the test participants (operators, supervisors, data collectors, and test directorate) recommended four-person crews for LPA erection/lowering tasks. Human Factors personnel observed 10 uncontrolled falls of the masts. In one case, an operator had the mast fall onto his shoulder causing a painful injury.

Potential Solutions: If the current LPA masts continue to be used, using a hinged base plate would make erection easier and safer, but for safety would require four man crews for erection. Alternately, consideration should be given to use of telescopic antenna mast sections which are already in the supply system. The training program should demonstrate correct erection/disassembly procedures to all 26QD6 personnel during specialty training.

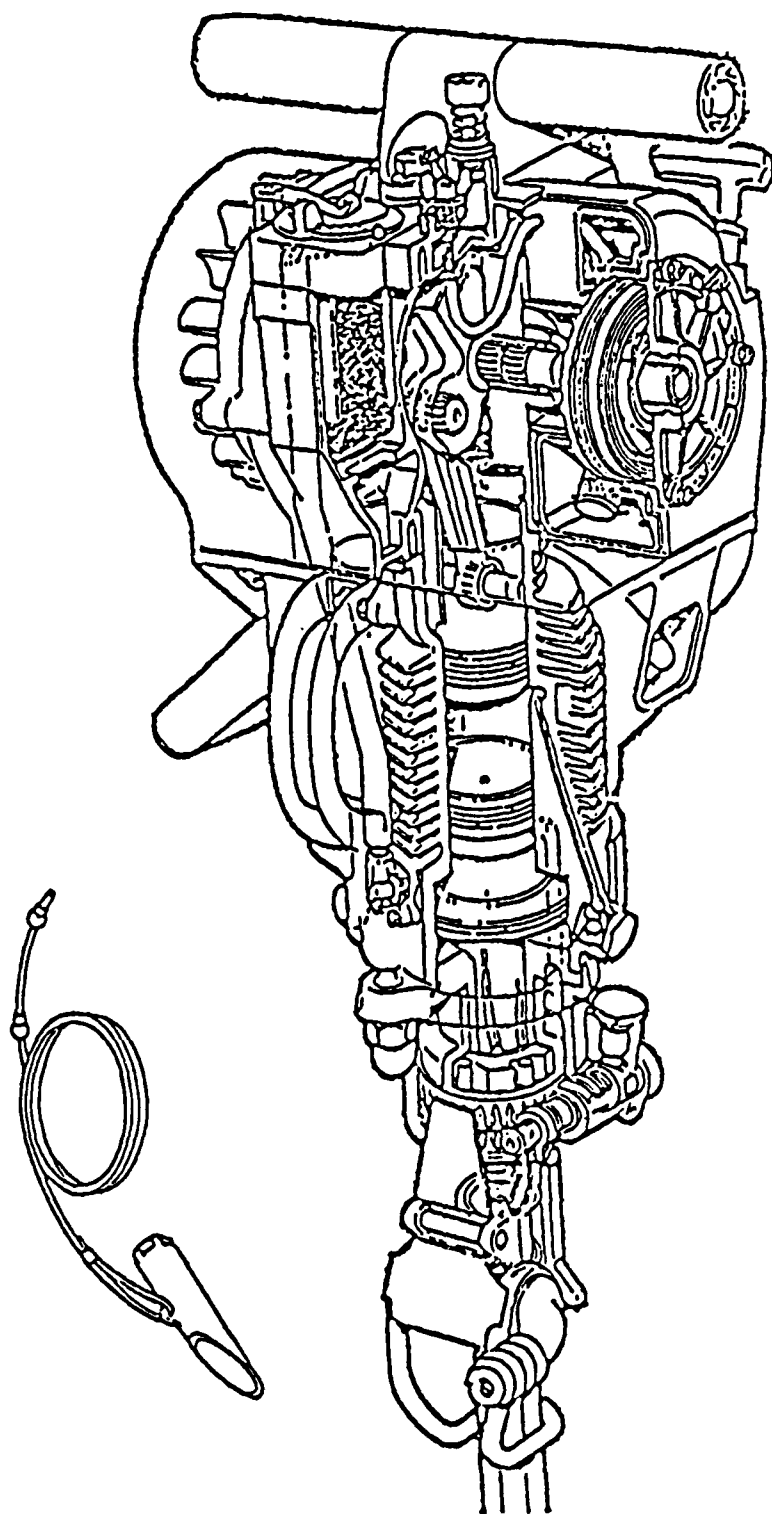
Figure 15. A cut-away view of the Pionjar drive motor and of the duckbill anchor.

Description of the Problem: Figure 15 shows a cut-away view of the Pionjar drive motor. Problems found on the non-militarized Pionjar included:

Data: Six Pionjars were unavailable due to maintenance problems during the test. The supply system issued improper oil for the oil and gas mixture that is required, causing some Pionjar failures. The crews in some distant sites had to obtain regular gasoline and 2-cycle motor oil from retail stores in order to operate the Pionjar.

Potential Solutions: A separate test of the Pionjar is needed. The device should also be required to meet military packaging and labeling standards. The logistics issue need review.

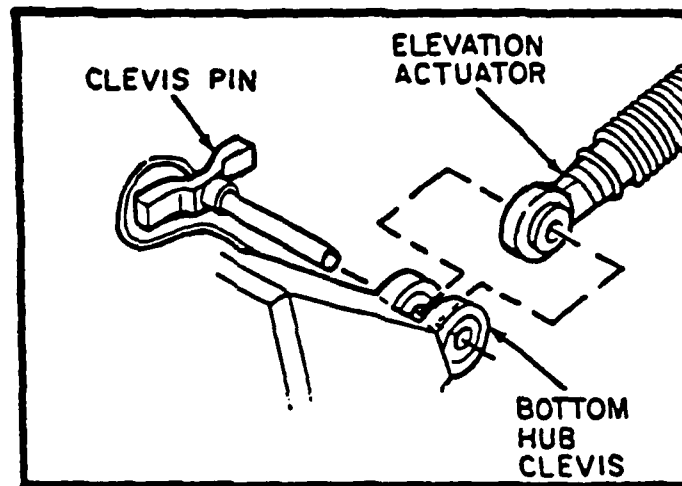
Figure 16. An example of the type of pin that was difficult to insert and remove.

Description of the Problem: Figure 16 shows the type of clevis pins used to secure and assemble equipment. The clevis attachment pins used on the AN/TRC-170 antennas are difficult to handle. The pins are used to hold the antennas together and to secure antenna parts to the low-profile pallet. The pins fit tightly and are difficult to install and remove. The pins have been damaged by attempts to install or remove them using improper tools such as hammers, rocks, and other objects.

Implications: The pins slow the assembly and disassembly process. There are no replacement pins supplied to the unit. Lost or damaged pins may make assembly or disassembly dangerous or impossible.

Data: Every unit had damaged pins. Replacing the pins was logistically difficult.

Potential Solutions: The pins should be treated with an approved lubricant to control corrosion and facilitate insertion. The holes receiving the pins should be flanged to help insertion/removal. Crewmen suggested that a rubber mallet be issued and used to insert or remove pins.

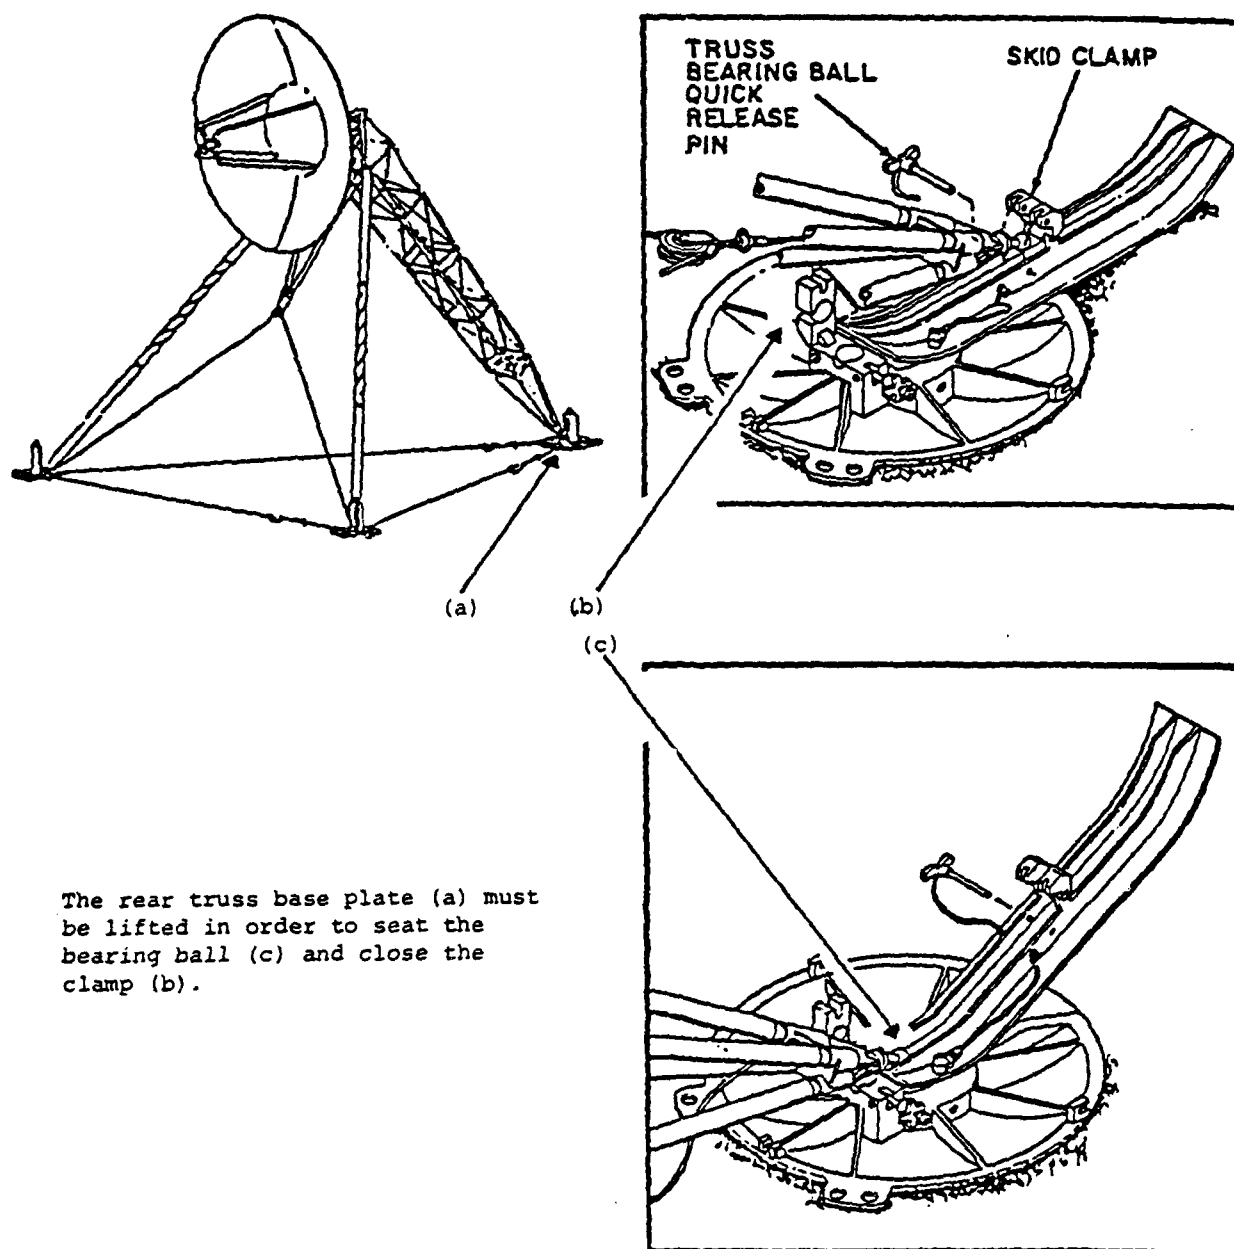
Figure 17. The 9.5-ft antenna (a), rear truss clamp (b), and bearing ball (c).

18. Binding of the antenna rear truss clamp. (V3)	The antenna rear truss clamp binds and cannot be closed without lifting the loaded base-plate.	Crew injury. Equipment damage.	19. <u>C</u>	<u>1</u>

Implications: The operators may be injured an/or the antenna damaged. The rear truss might slip out of the base plate and fall. The antenna would become inoperable due to damage.

Data: The problem has been observed on 5 of the 12 antenna systems in test. The problem was not corrected on all the fielded antennas by the end of the test.

Potential Solutions: The rear clamp assembly needs to be modified. The new antennas in production should be modified prior to fielding.

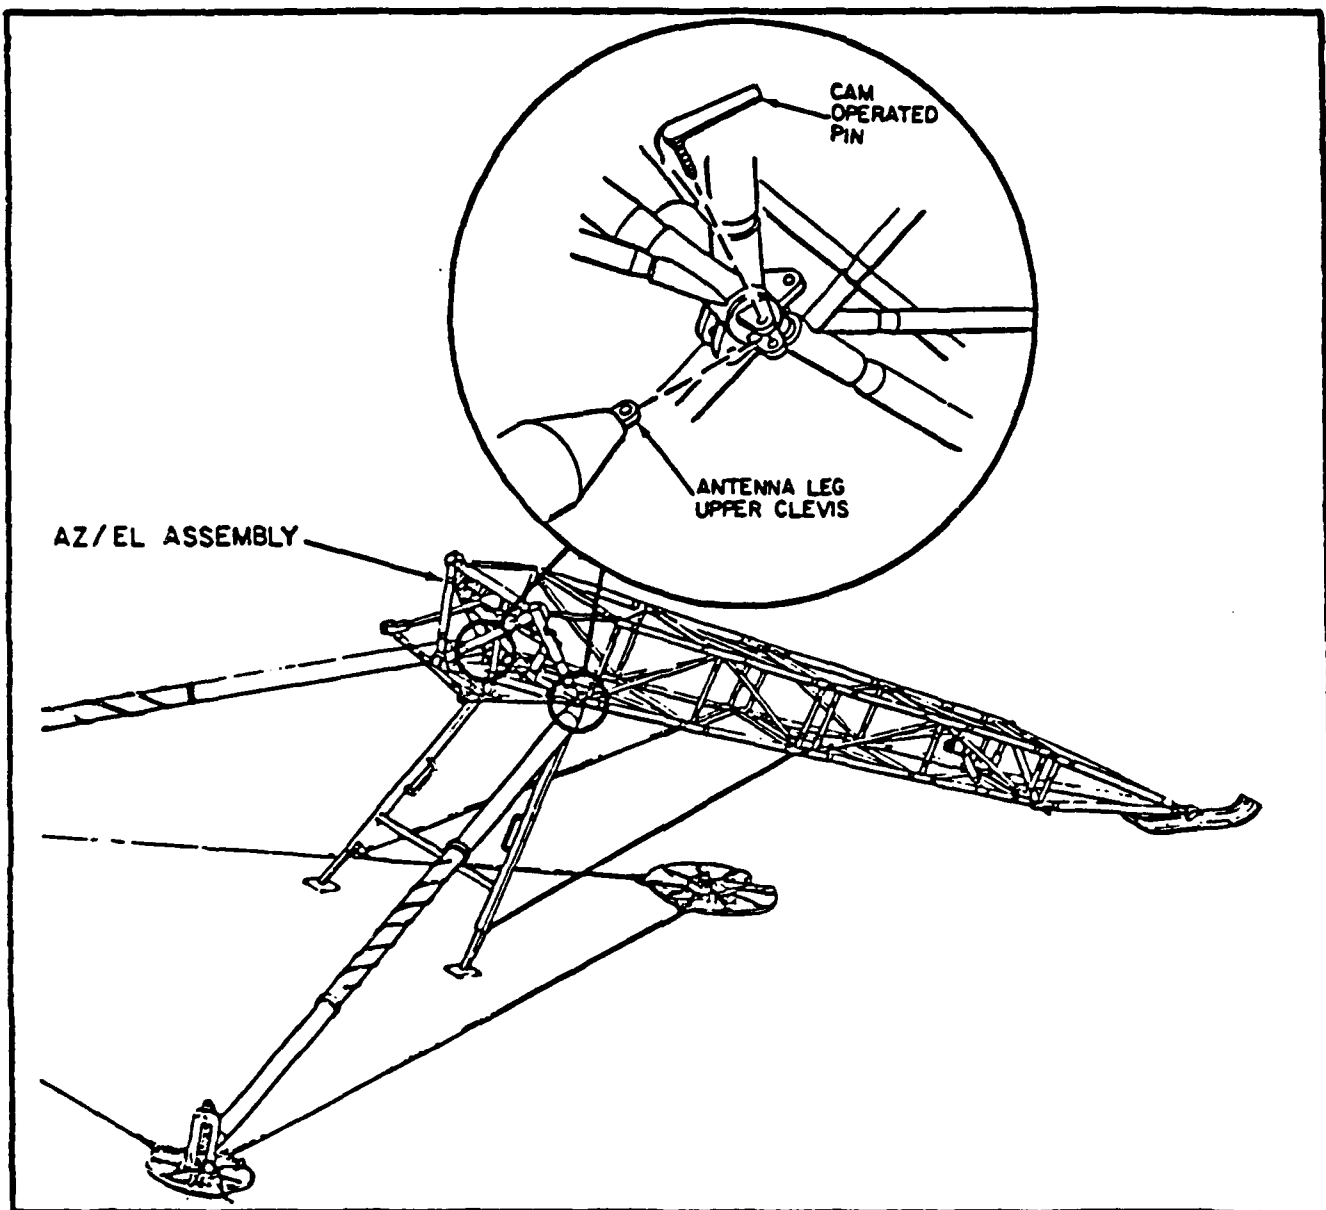
Figure 18. An example of the type of manipulation task that could be performed more rapidly by crewmen using a stepladder or platform.

Implications: The use of field-expedient methods used by crews may involve the use of unstable and dangerous platforms. The antenna structure was not designed for climbing or standing on the cross braces. Equipment damage may result from climbing up the truss assembly.

Data: Sixty-three percent (63%) of the operators reported observing personnel climbing or reaching in a dangerous manner. One operator broke his finger in the process of releasing the support struts for the AZ-EL assembly. Numerous reports were received concerning the dropping of antenna parts while crewmen were reaching and climbing.

Potential Solutions: Provide a stand as standard equipment issue for the AN/TRC-170(V2). It is recommended that at least a 3-ft high stand or ladder be supplied.

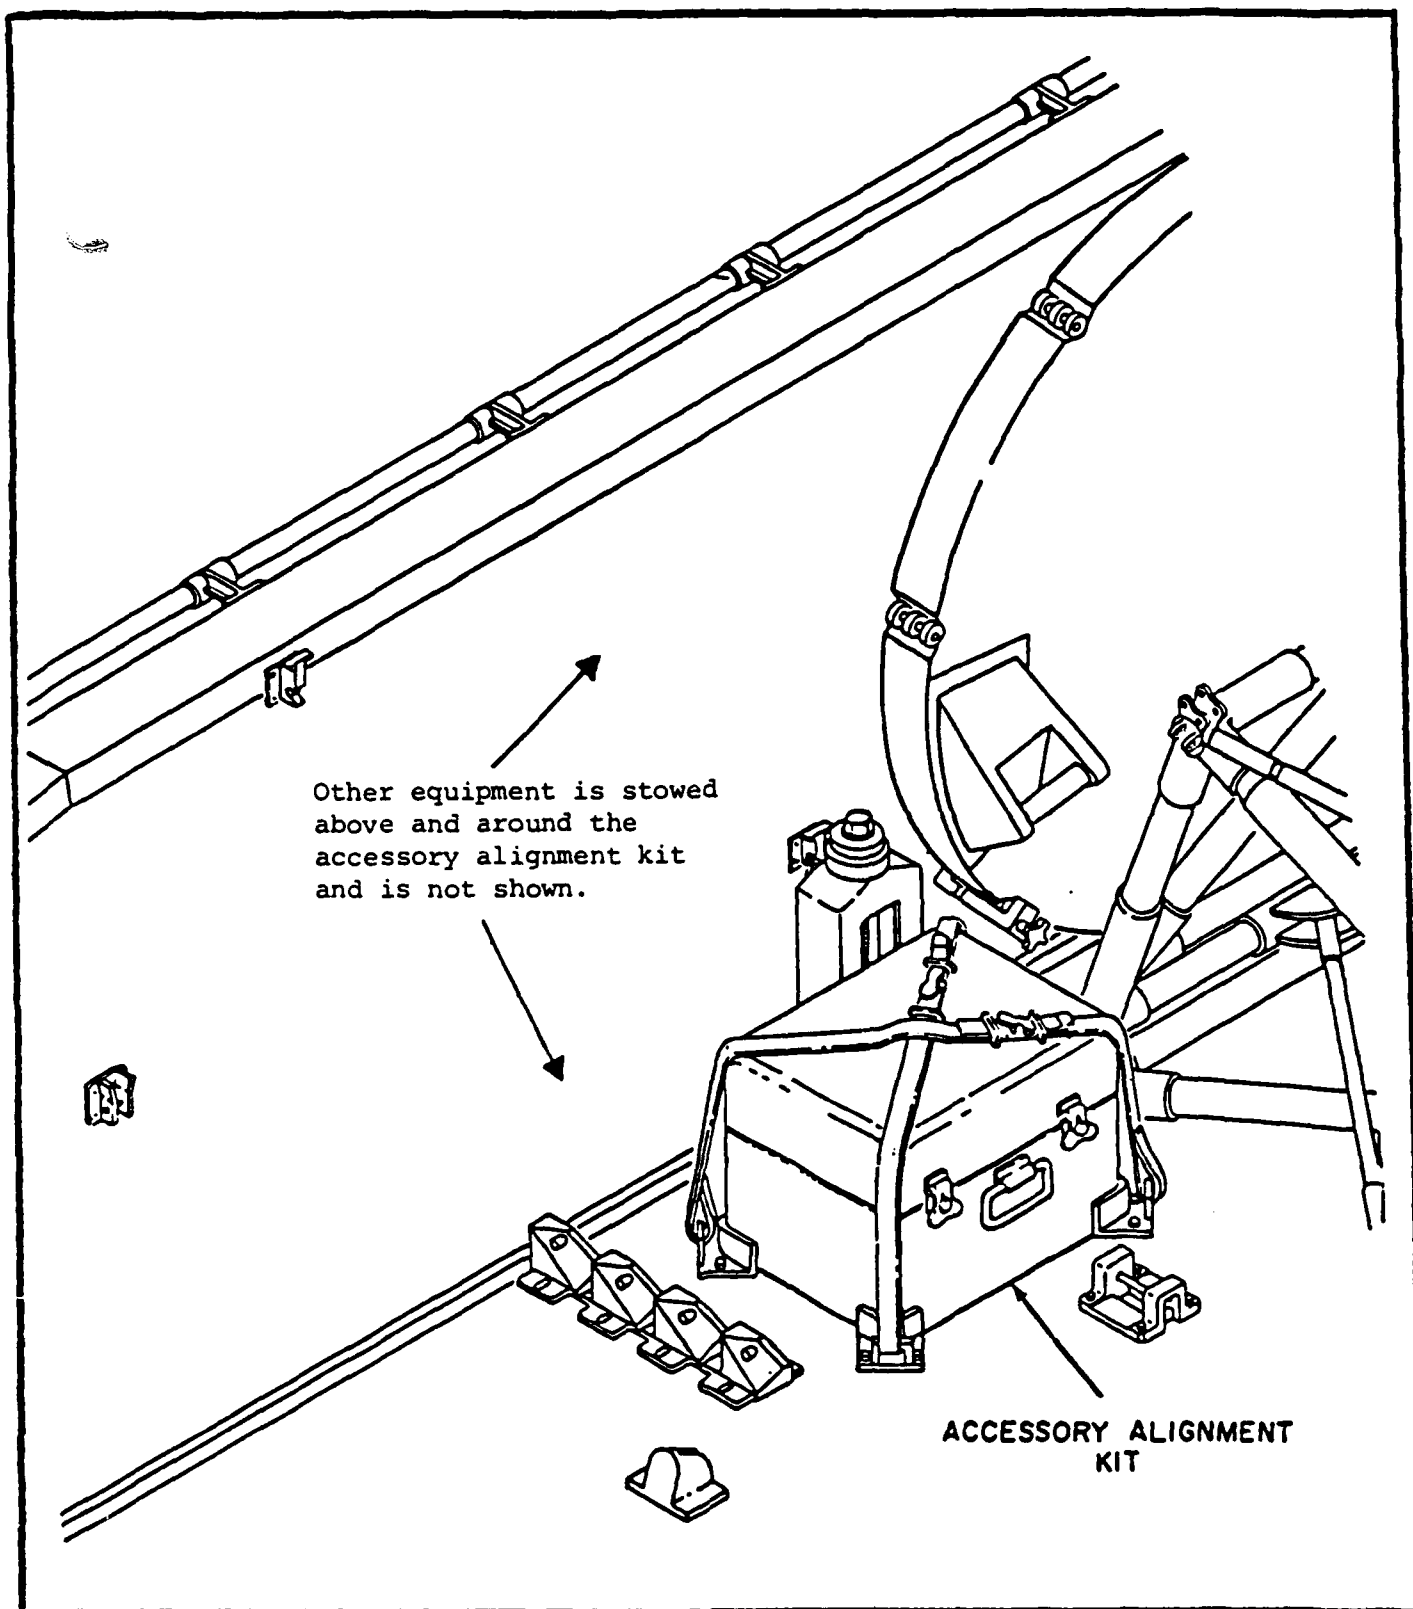
Figure 20. The interior of the low-profile pallet showing the location of the accessory alignment kit.

Data: Fifty-one percent (51%) of all the operators recommended that the location of the accessory kit be changed. Seventy-five percent (75%) of the crews moved the kit to either the truck cab or the shelter by the midpoint of the test without the direction of senior test participants.

Potential Solutions: The accessory kit should be placed in the shelter near the door or in the truck cab area for easy access.

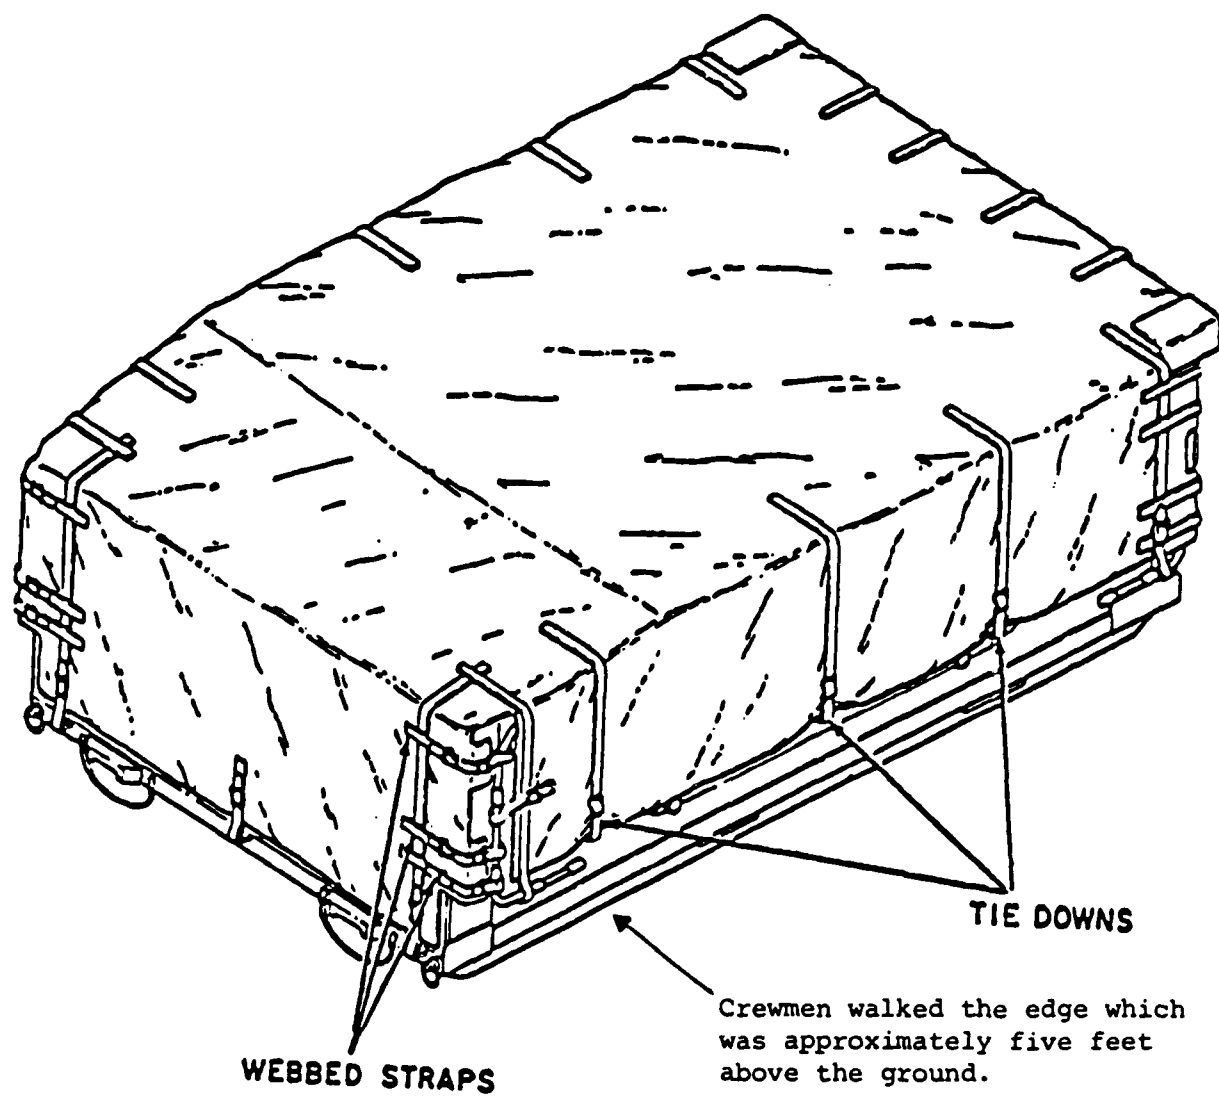
Figure 21. The low-profile pallet which was mounted on a 2.5-ton truck.

Data: Seventy percent (70%) of the crewmen reported that it was difficult for three crewmen to load and unload the low-profile pallet.

Potential Solutions: The canvas cover over the low-profile pallet could be provided with a drawstring arrangement so that personnel would not have to climb the side of the truck. The load on the low-profile pallet should be redistributed to facilitate loading and unloading, and consideration should be given to moving some of the load to the shelter.
